The Secretary  
of the Interior's  
Standards for  
Rehabilitation &

**I**llustrated  
Guidelines  
for  
Rehabilitating  
Historic  
Buildings

U.S. Department of the Interior  
National Park Service  
Cultural Resources  
Heritage Preservation Services

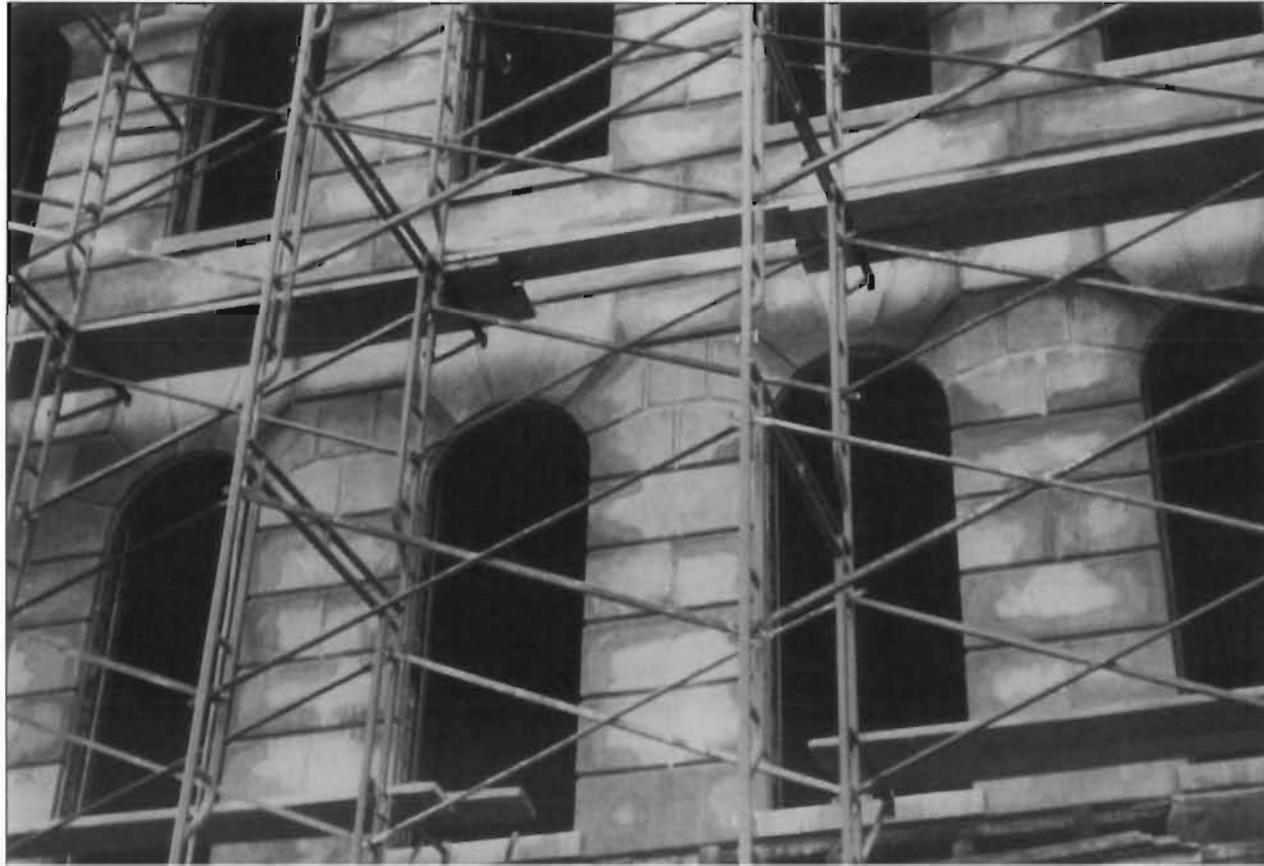
*Composite patching with a cementitious mixture is being used to repair eroded areas of this sandstone facade.*

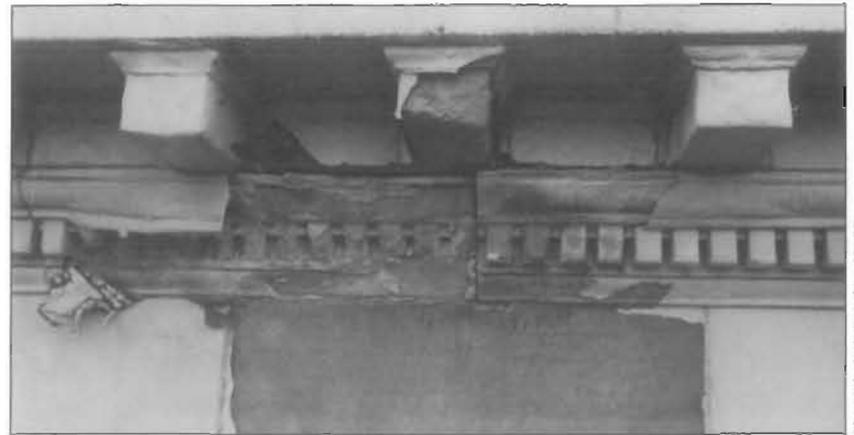
*Excessive moisture has damaged not only the stuccoed wall surface, but also the brick substrate.*

*Moisture from a faulty roof and drainage system has been trapped inside this limestone cornice by a waterproof coating, causing severe damage to the stone.*

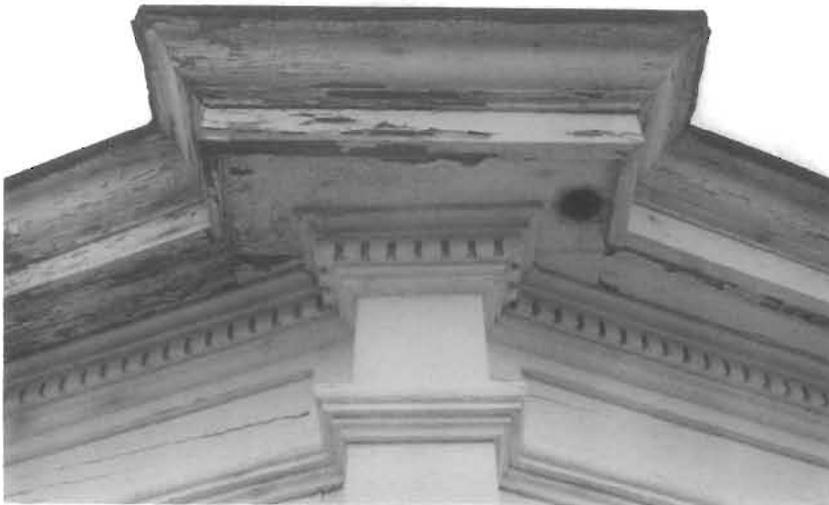
*Due to lack of maintenance, the paint has peeled to bare wood. In order to survive, this cornice will need to be scraped, sanded, and re-painted together with other essential repairs.*

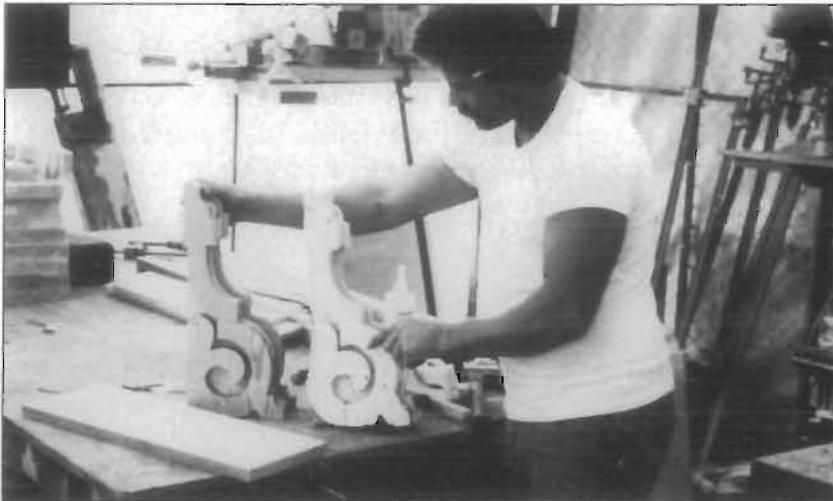
*If a character-defining feature is missing, it should be replaced with a matching feature. This shop artisan used traditional tools to replicate a missing porch bracket; after the new bracket is painted, both original and duplicate will be installed on-site.*

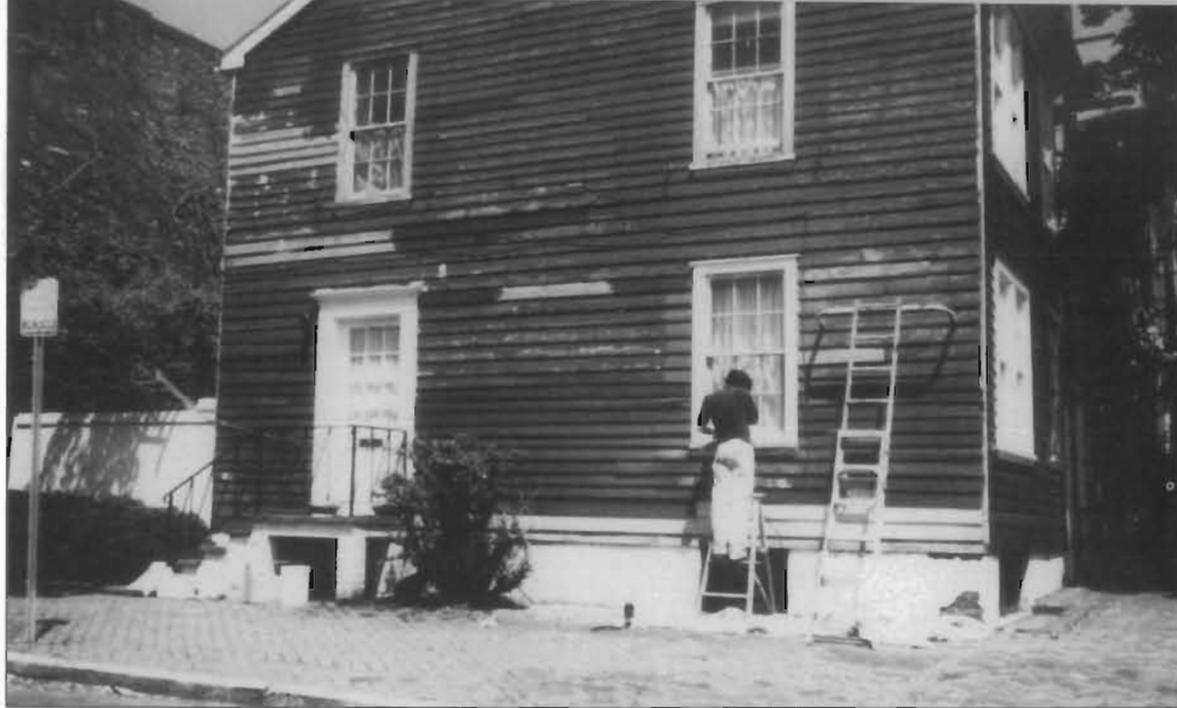
*Deteriorated clapboards are being selectively replaced, thereby maximizing retention of the historic siding.*

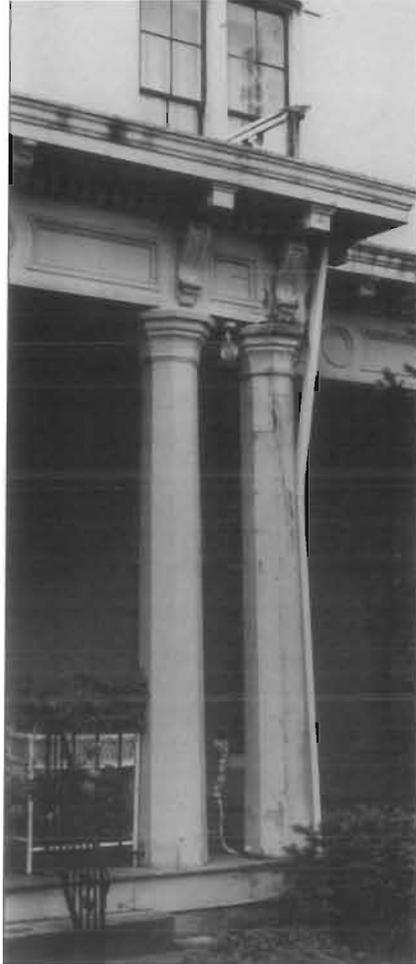
*The roof drainage system has been neglected for such a long time that, as a result, the wood cornice and a porch column are both severely deteriorated.*

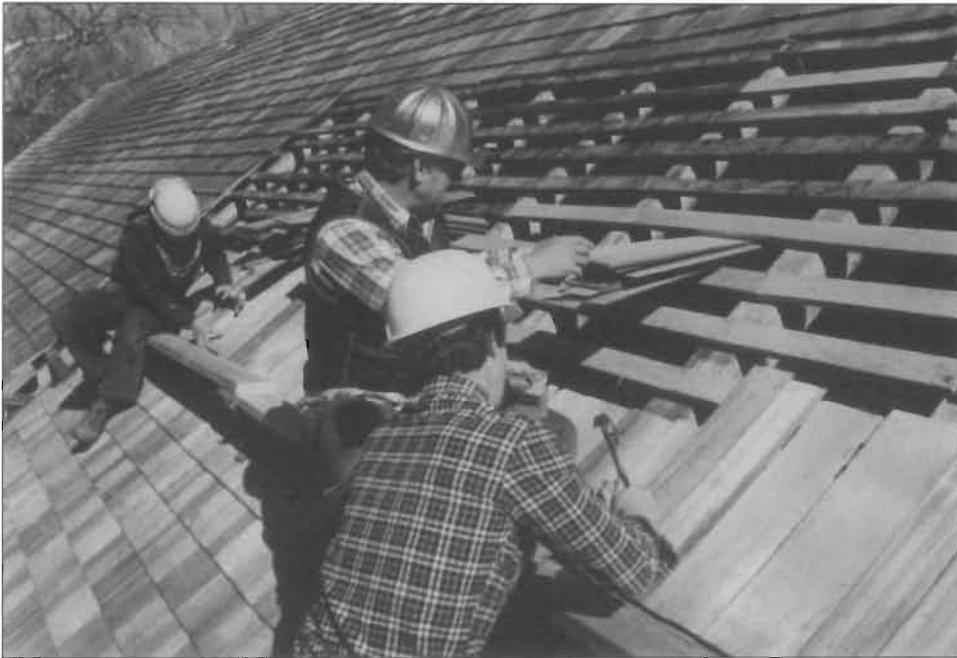
*The size, shape, and detailing of the historic shingles as well as the method of fabrication and installation were carefully researched prior to selecting this new wood-shingle roofing.*

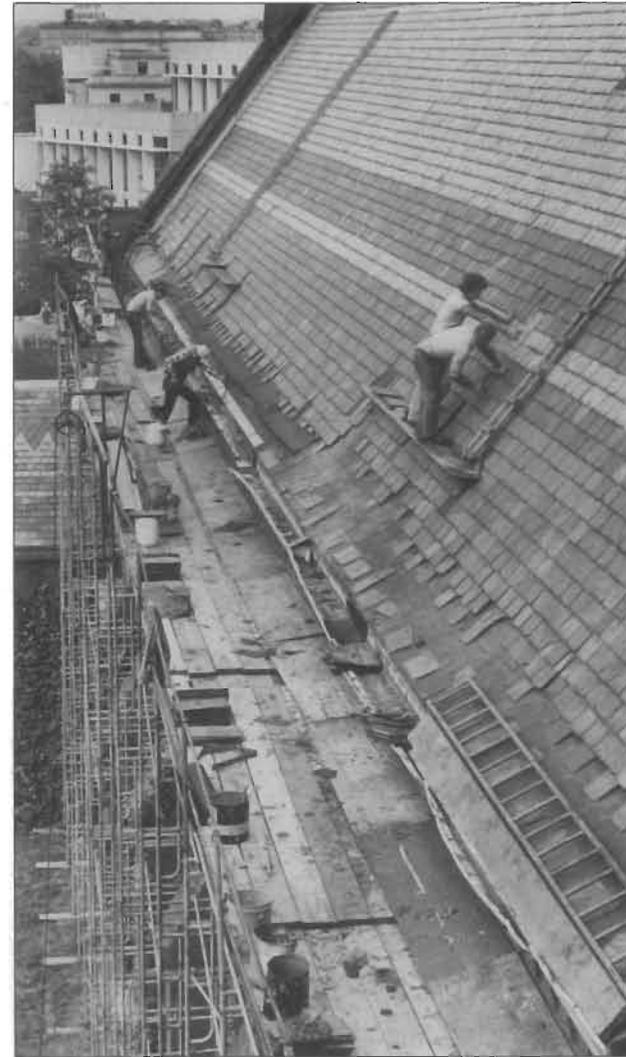
*Workmen are in the process of removing deteriorated roofing slates and replacing them with new matching slates.*

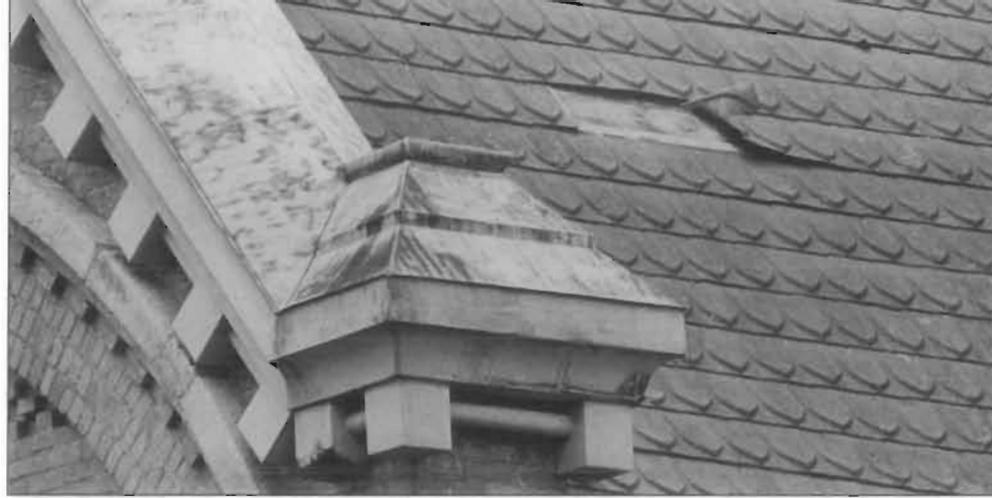
*New galvanized sheet-iron shingles will need to be reproduced using the pattern of the original shingle.*

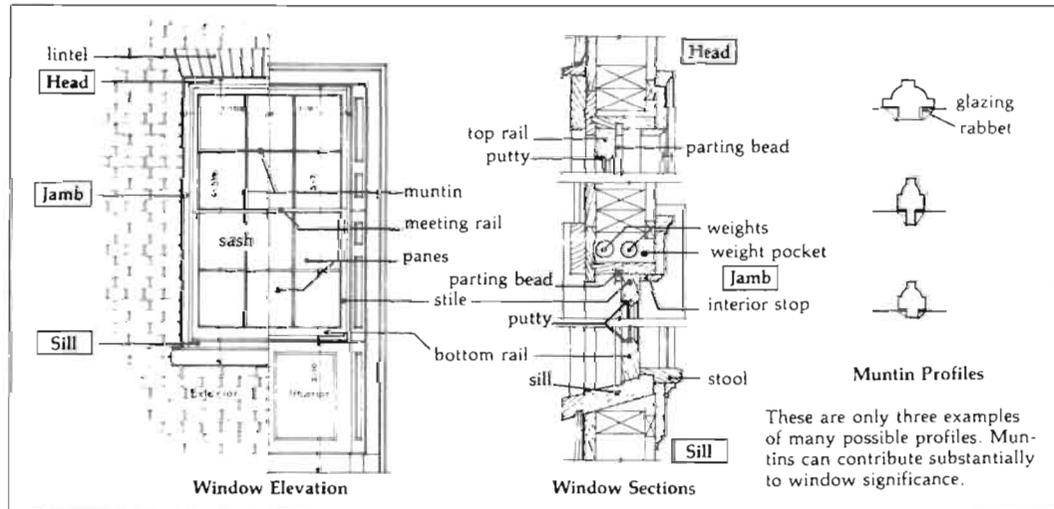
Deterioration of poorly maintained windows usually begins on horizontal surfaces where water collects. Problem areas on this sill are clearly indicated by paint failure due to moisture.

These are only three examples of many possible profiles. Muntins can contribute substantially to window significance.

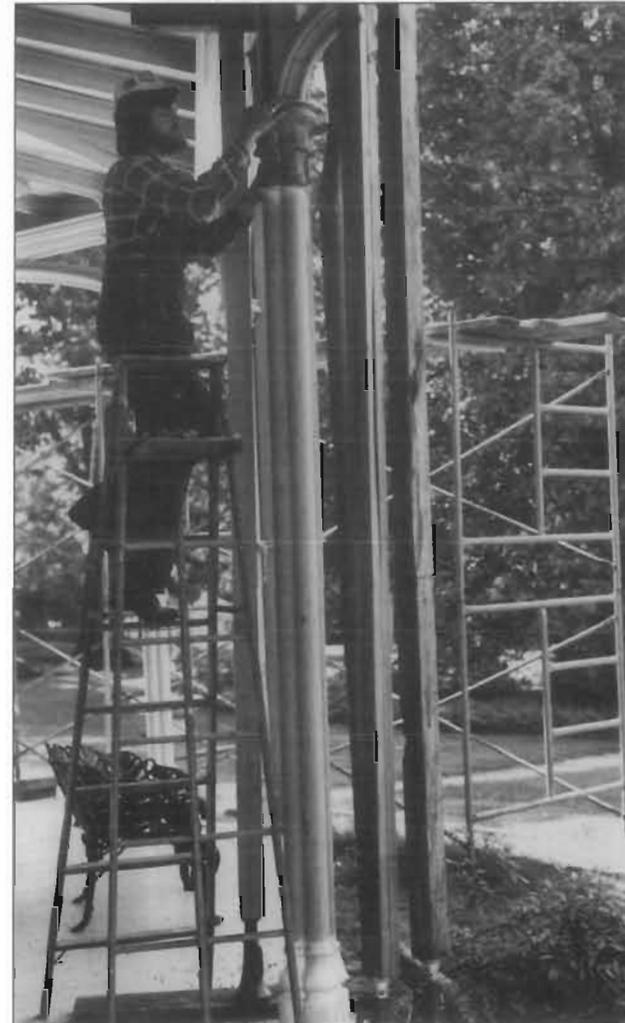
*Careful inspection of porch features such as these column capitals is necessary before initiating a rehabilitation project.*

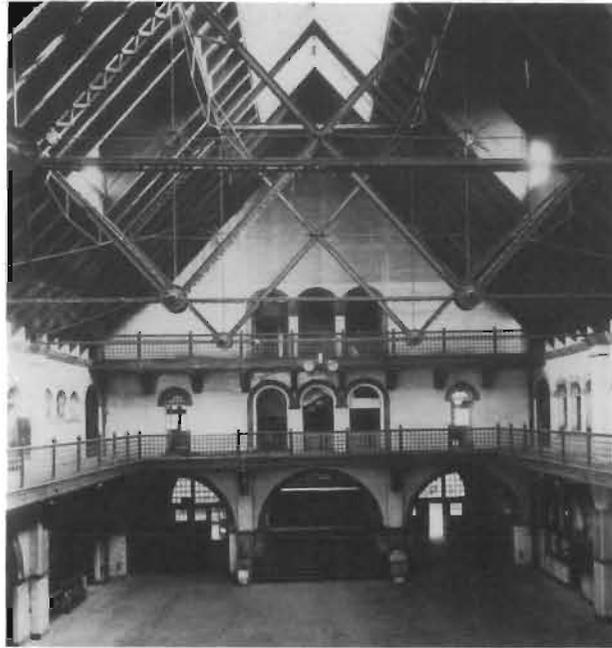
*The exposed metal roof-truss system of this waiting room not only provides structural support, but is also important in defining the interior character of the train station.*

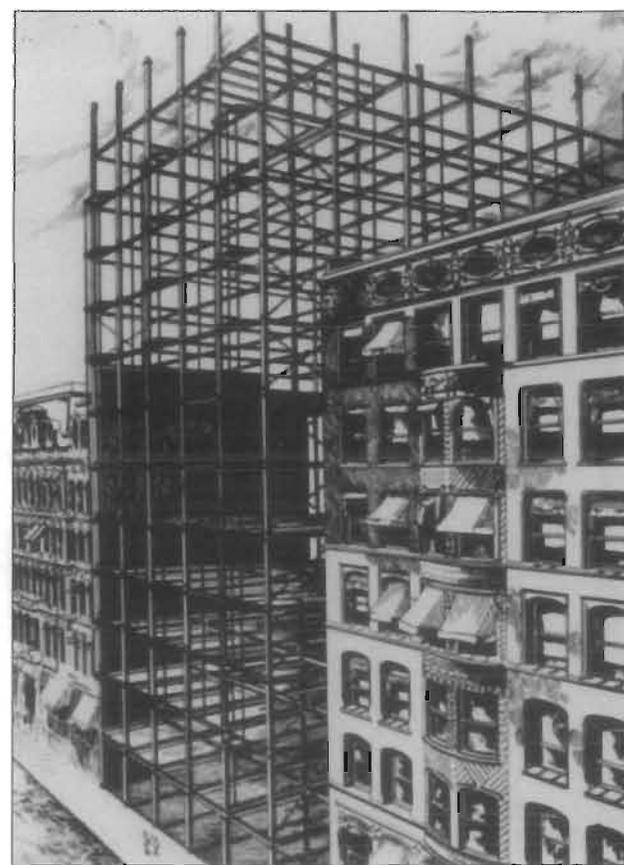
Iron and Steel Skeleton Frame, Unity Building, Chicago, Illinois, 1891-1892 (Clinton J. Warren, architect). *The development of the skeleton frame was pioneered by architects of the "Chicago School" in the late-19th century. With this method the weight of the building is carried on the frame, not the walls, allowing the construction of taller buildings without increasing the wall thickness.*

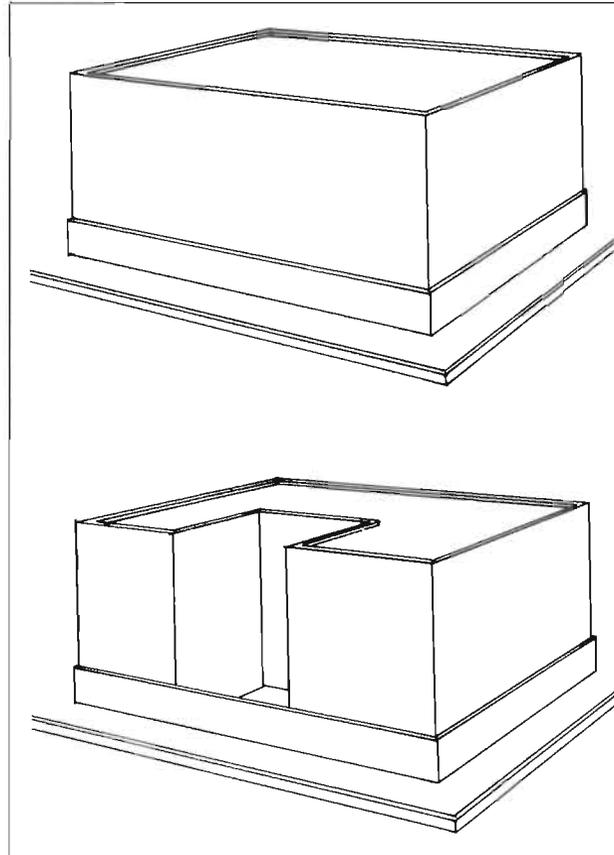
*A rehabilitation proposal to convert a historic waterfront warehouse into a residential apartment building called for cutting out a large section of the rectangular-shaped historic building. The new “U” shape would provide more apartments with a waterfront view. This schematic drawing shows the drastic change that would result to the structure and character of the historic building if a portion had been removed as proposed (the project was denied because it did not meet the Standards).*

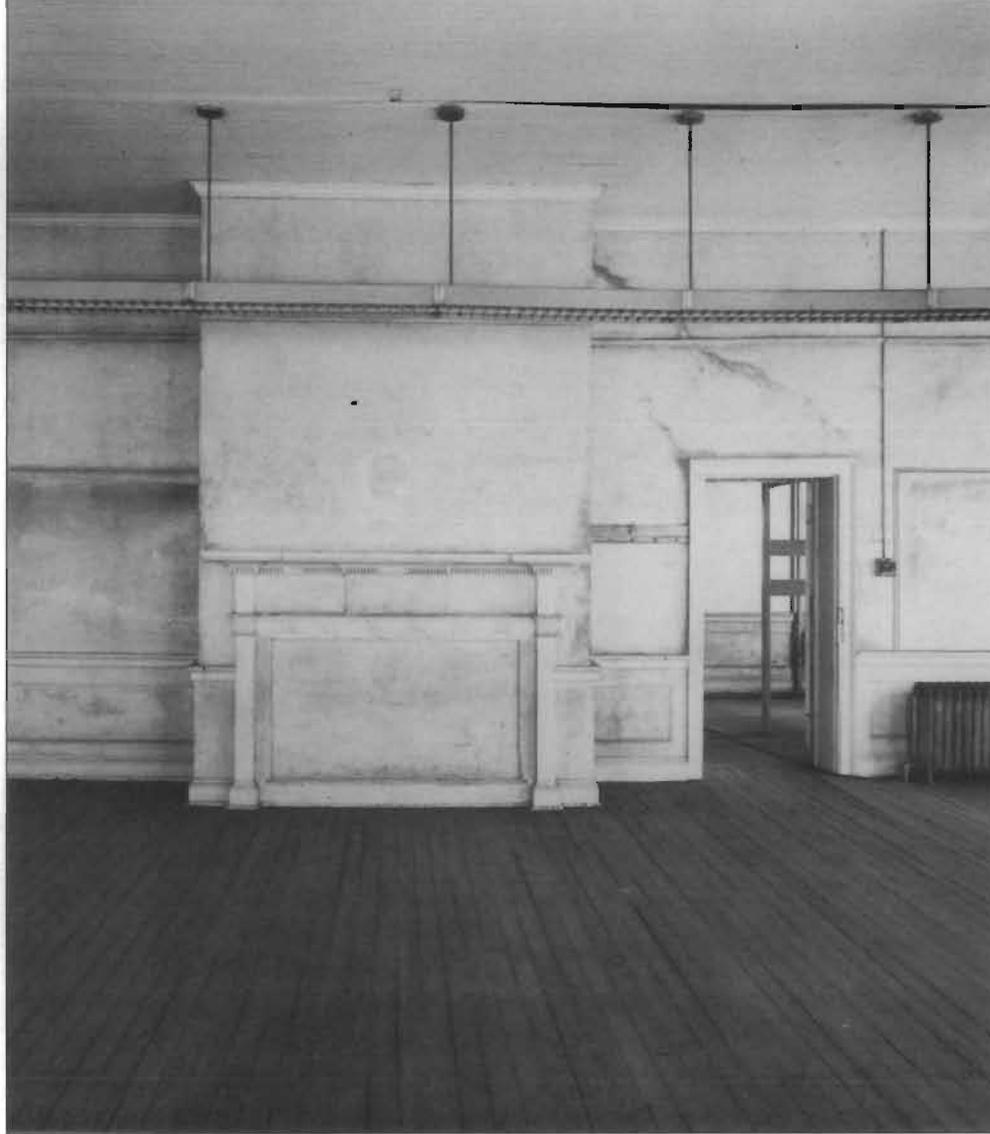
*This row of hanging fluorescent lights installed in an earlier renovation mars an otherwise classically detailed interior. They have also caused the historic beaded ceiling to pull away from the joists.*

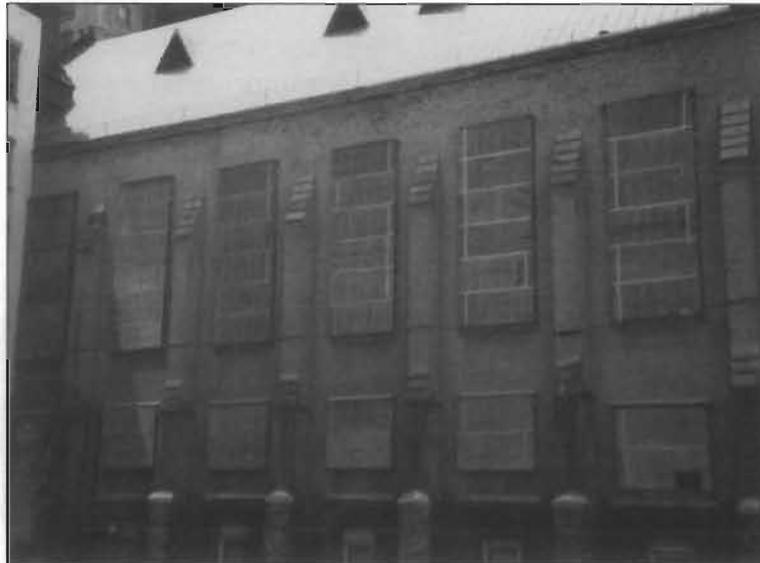
▲► The roof and stained glass windows of this historic church have been appropriately covered with plywood as a protective measure during construction of a new building on an adjacent lot.

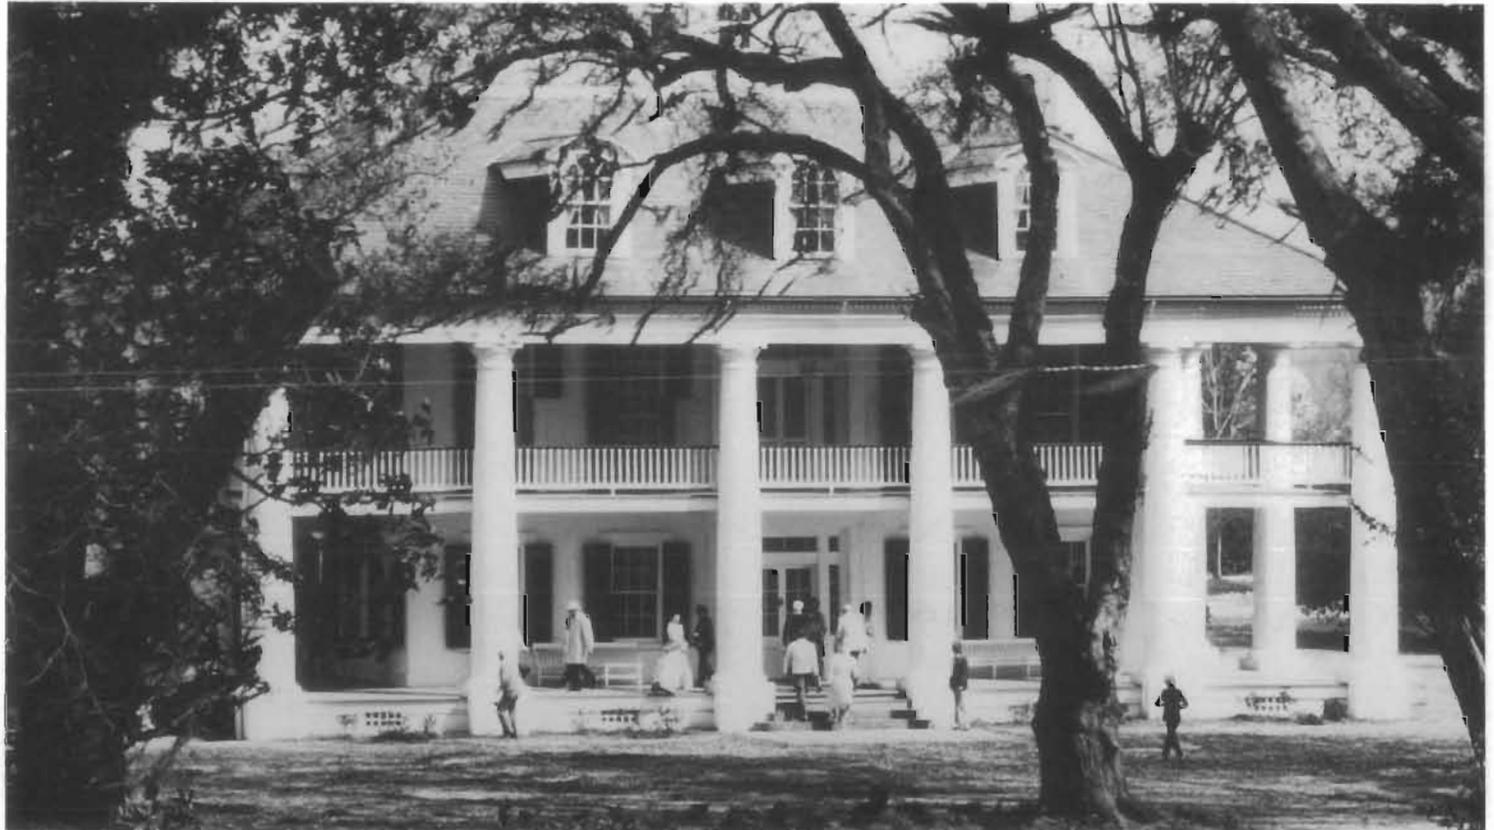
*In hot climates, buildings were historically designed to minimize the heat gain from the summer sun. The wide roof overhangs, exterior porches, shutters, shade trees, and heavy masonry walls (painted white) are all energy saving characteristics.*

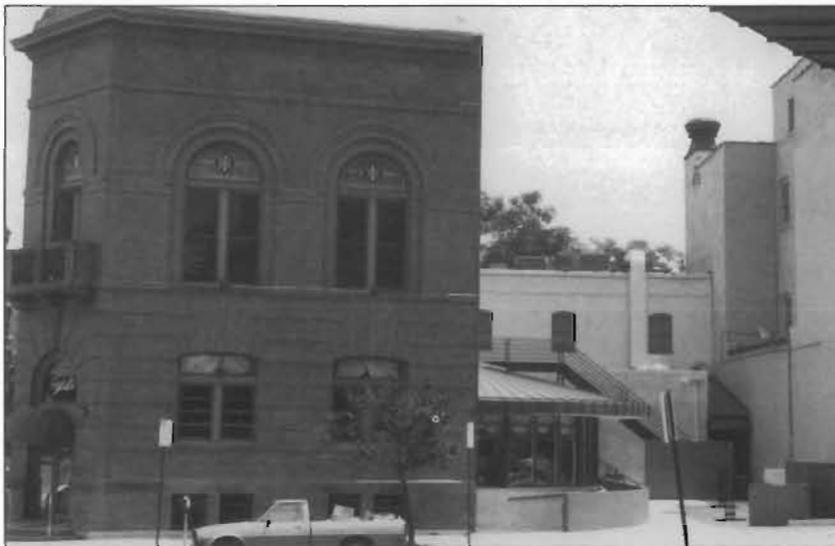
*In rehabilitating a historic bank for a new use, a small restaurant addition was built on the rear. The new addition is compatible with the historic building primarily because of its scale and location.*

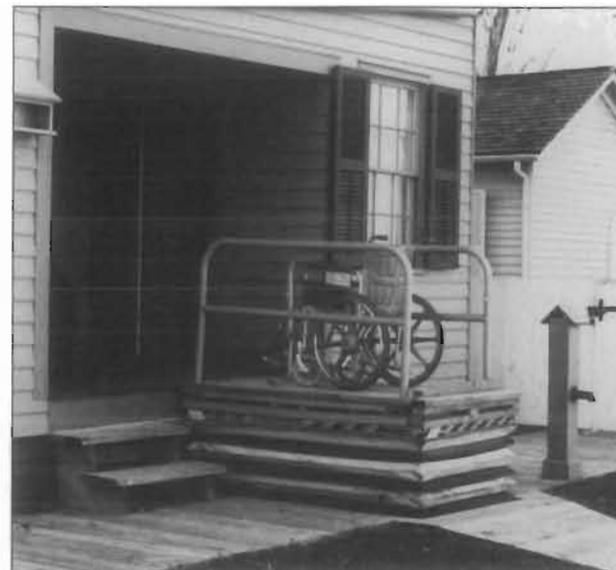
An accordion-type platform lift that retracts to ground level when not in use has been installed to make this historic house accessible.
